# HERON

vol. 18  
1972  
no. 2

### CASES OF DAMAGE TO PRESTRESSED CONCRETE

*Th. Monnier (IBBC)*

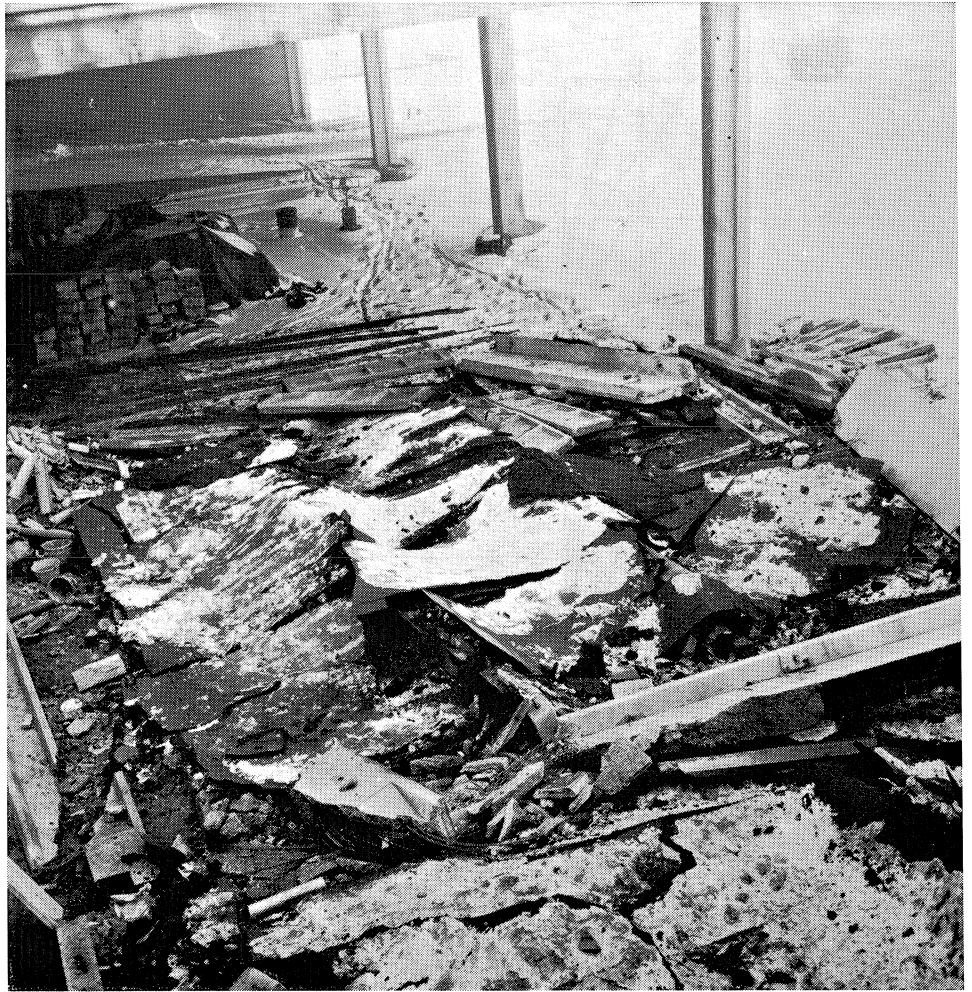
Fig. 2. Damage caused by absence of stirrup reinforcement in beams loaded through corbels (1963).

disastrous. This clearly emerges from Figs. 3 and 4. Just as in the actual instance of damage illustrated in Fig. 2, at a particular instant the bottom flange becomes completely detached from the rest of the beam (see Fig. 5). The bending moment at which this happens is, however, relatively far below the anticipated failure moment of the beam section and generally corresponds to the cracking moment. Detachment of the bottom flange takes place very abruptly, without any previous warning. From the investigation of the beams with corbels and from the strain measurements performed in this context it became clearly apparent what actually happens in such circumstances.

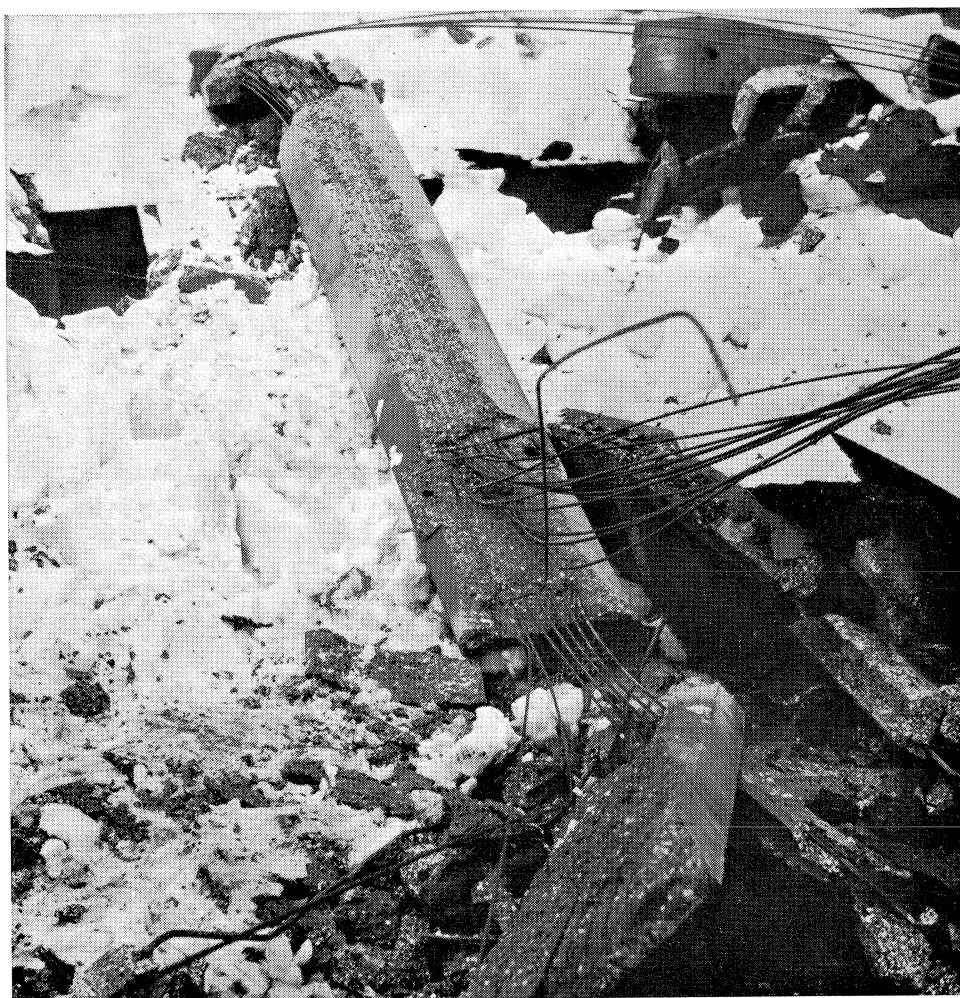
Fig. 5. Detached bottom flange of a beam loaded through corbels and containing no stirrups.

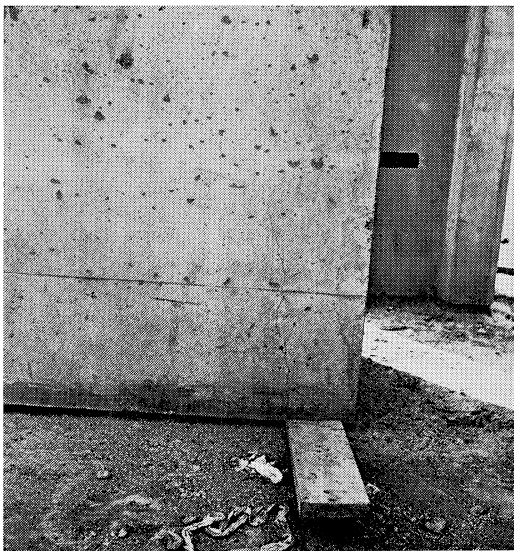
Fig. 28  
Typical cracking at the end of a beam.

1. There is direct concrete-to-concrete contact at the bearing.
2. The part of the beam directly over the bearing is unreinforced.
3. The effect of the prestress is lacking in the part of the beam directly over the bearing.
4. The beam is fixed to the bearings without any latitude for deformation.
5. The bearing length (or depth) is too small.

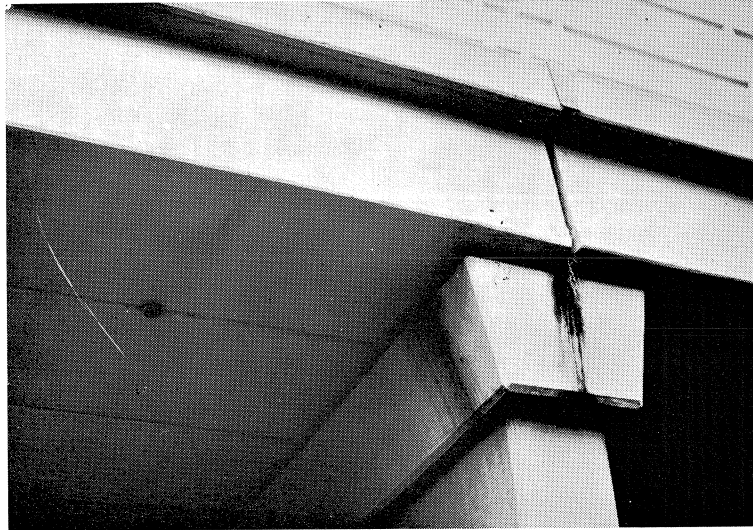
Fig. 41.  
Inadequate  
provision for  
rainwater  
discharge  
produced this  
unsightly  
appearance.

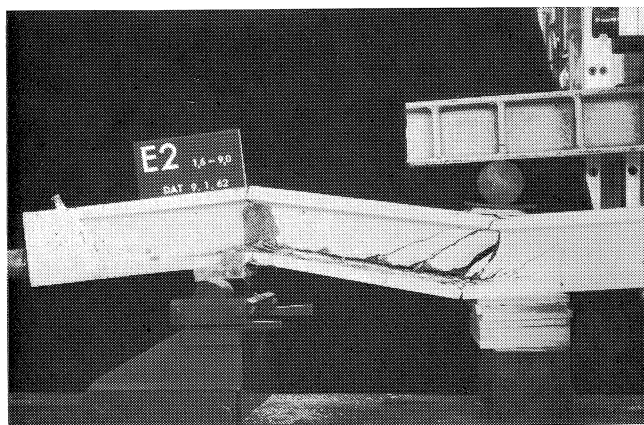
Fig. 60.  
Beam after failure in shear loading test.

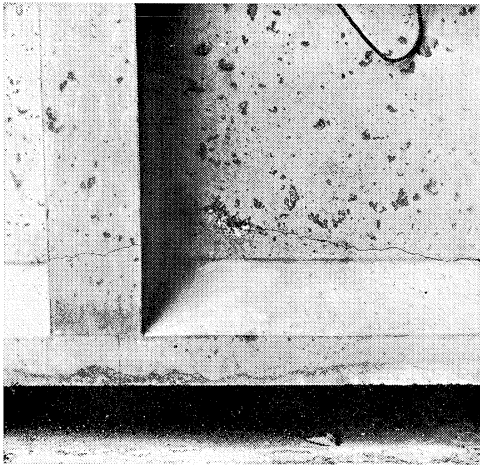
Fig. 62. Cracking due to secondary tensile stresses caused by a displaced cable duct.

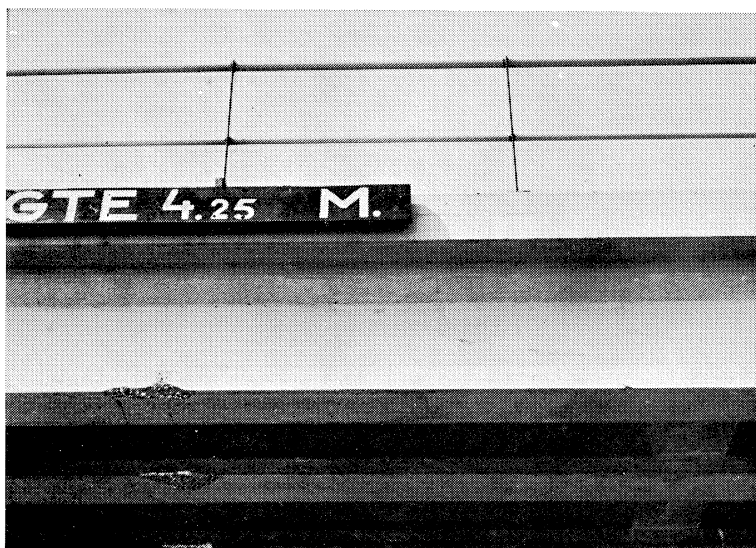
Fig. 80.  
Damage due to  
collision on a  
bridge con-  
structed from  
precast pre-  
stressed concrete  
beams.

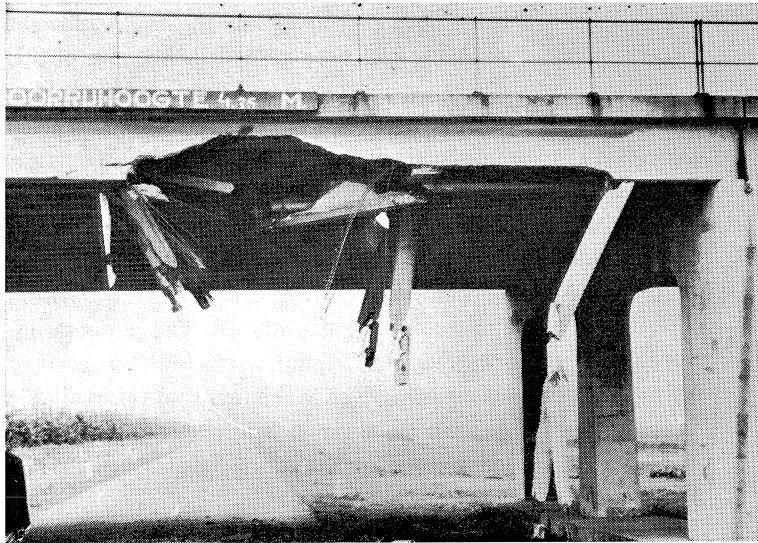
Fig. 81.  
The consequences  
of a serious  
collision.

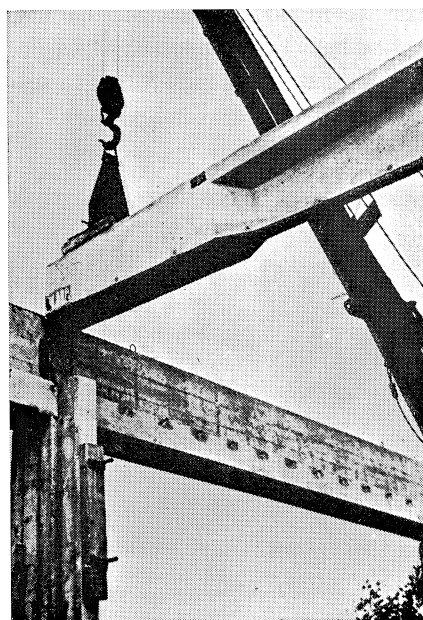
Fig. 86.  
Special attachment to raise the level of the  
slinging point and thus prevent toppling.
