Durability of marine concrete structures – field investigations and modelling

Rob B. Polder

TNO Building and Construction Research, Delft, The Netherlands

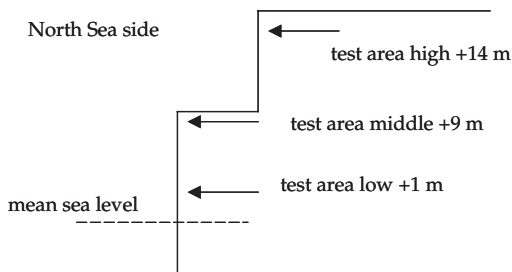
Figure 2 Schematic of a pier of Haringvliet spuisluizen (discharge complex)

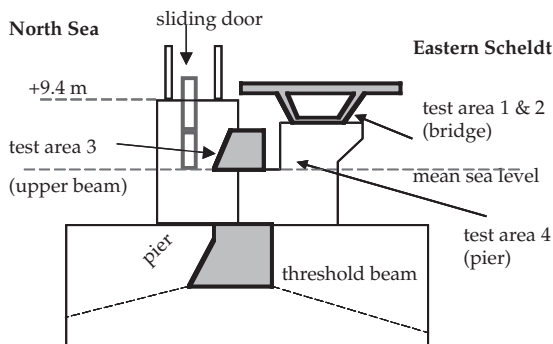
Figure 3 Side view of Eastern Scheldt Storm Surge Barrier Pier with test areas indicated; NB test area 2 is in lightweight concrete in another span than the other three test areas

For heights above + 7 m, two different patterns were present in the data. For the bridge elements of the Eastern Scheldt Barrier (at +9 m), high values of about 5% were found (Table 4).

This can be explained by considering that here the concrete is relatively sheltered from rain by the bridge deck above the test area (see Figure 3), so most of the chloride deposited on the concrete surface by splash and wave action is accumulated without being washed away. On the other hand, for the middle and high parts of the Haringvliet pier (+ 9 and +14 m), surface contents of 1% or lower were found. In these parts the concrete is fully exposed to rain and at a relatively high distance from seawater splash and waves, so the balance between accumulation and washout is the other way around than in the Eastern Scheldt Barrier.

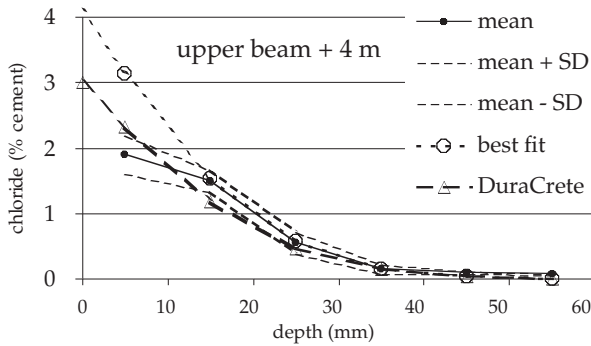
As an example, Figure 4 presents the measured chloride profiles (mean of six; mean plus and mean minus standard deviation), the best fitting diffusion profile using equation (2), neglecting the first data point, and the DuraCrete prediction from equation (1) for the test area on the upper beam of the Eastern Scheldt Barrier (age c. 18 years). For input parameters for the DuraCrete prediction see Table 3. The Figure shows that in the zone 0 – 10 mm strong differences exist between measured, fitted and predicted chloride profiles; however, beyond 10 mm depth they are all quite close. The 'best fit' curve coincides with the mean measured curve from 15 mm (10 – 20 mm) on. The DuraCrete prediction is a bit lower than the mean measured curve, close to the 'mean minus standard deviation' curve. Actually in this example the scatter is relatively low; in most cases, much larger scatter was present. Mean and standard deviations for diffusion coefficients and chloride surface contents from the best fitting curves for the test areas (using equation (2)) are presented in Table 4. Means of profiles from quay wall Noordland have been added.

Figure 4 Chloride profiles from the test area on the upper beam of the Eastern Scheldt Barrier (after 16 years); mean of six measured profiles, mean plus and mean minus standard deviation; best fit with equation (2) and prediction according to the DuraCrete model with equation (1)

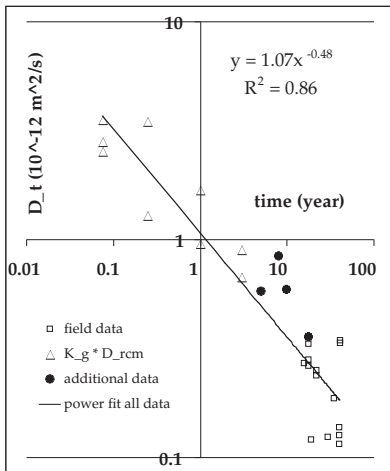
The second deviation for DuraCrete concerns the time dependency of the diffusion coefficient. Three groups of diffusion coefficients were analysed: data from our test areas (Table 4); data from additional chloride profiles for concrete in marine environment after 8 to 16 years including those from Noordland and specimens submerged in the North Sea [Polder & Larbi 1995]; and from RCM testing of laboratory specimens up to three years age. These latter were multiplied by K_G as given above to transform them into effective diffusion coefficients. As presented in Figure 5, these three groups of data showed a satisfactory fit to a straight line in a plot of log D versus log t, with a (negative) slope of about 0.48 (standard deviation 0.07). For the combined datasets, an exponent of 0.48 best described the time dependency of the apparent chloride diffusion coefficient.

Consequently, a deviation was proposed regarding the value of the aging exponent. DuraCrete gives values for this exponent for Blast Furnace Slag cement concrete of 0.6 to 0.8. Most probably these relatively high values are based on data obtained from binders composed of Portland cement and slag that were added separately during concrete mixing [Bamforth & Chapman-Andrews 1994]. Such composite Portland-slag mixes may have different characteristics from Dutch slag cement, for which slag is intermixed with clinker during cement

production and whose properties are carefully monitored. According to experience with Dutch Blast Furnace Slag cement, this exponent should be lower. As mentioned above, the best fit to our extended dataset was obtained using a mean aging exponent of 0.48. It is interesting to note that Gehlen found a similar value of 0.45 for slag cement from literature data for profiles taken after up to 60 years [Gehlen 2000]. Taking into account the modified environmental coefficient and aging exponent, the (RCM) chloride diffusion coefficient at 28 days of the investigated concretes was inferred to be about $5.0 * 10^{-12}$ m^2/s. This value agrees well with laboratory test data for modern CEM III/B concrete with a w/c of about 0.5.

Figure 5 Compilation of diffusion coefficients from field work in this study, additional exposure data and laboratory data with best fitting straight line; note log – log scale
